**Natural Resource Damage Assessment
Florida Seagrass Recovery Project
Monitoring Report 2022
Last Updated 7/18/2022**

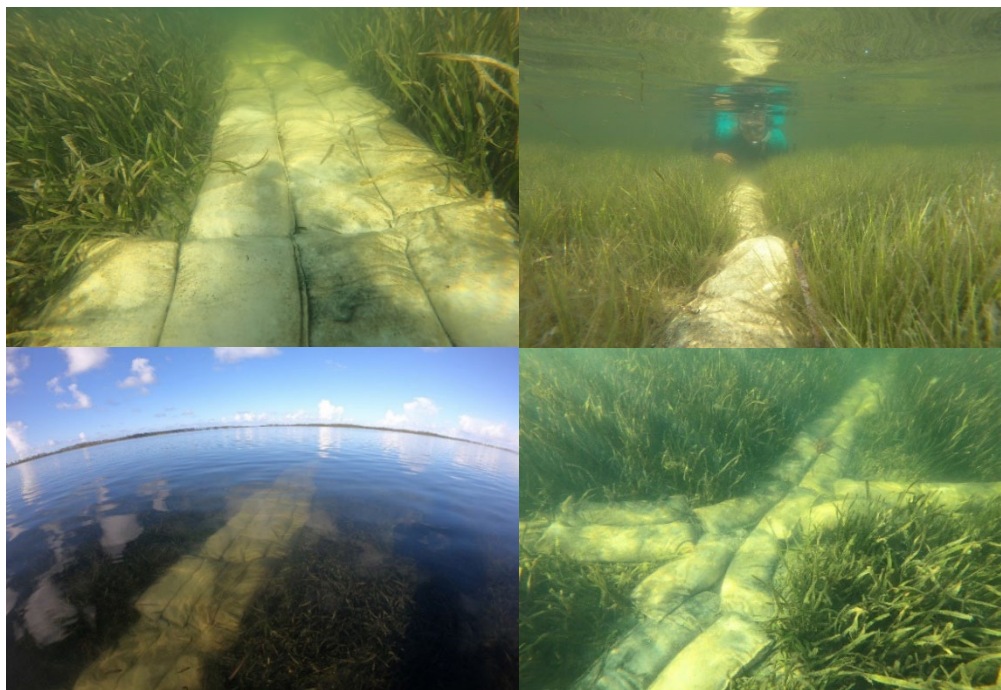
Figure 14: Examples of treated scars.

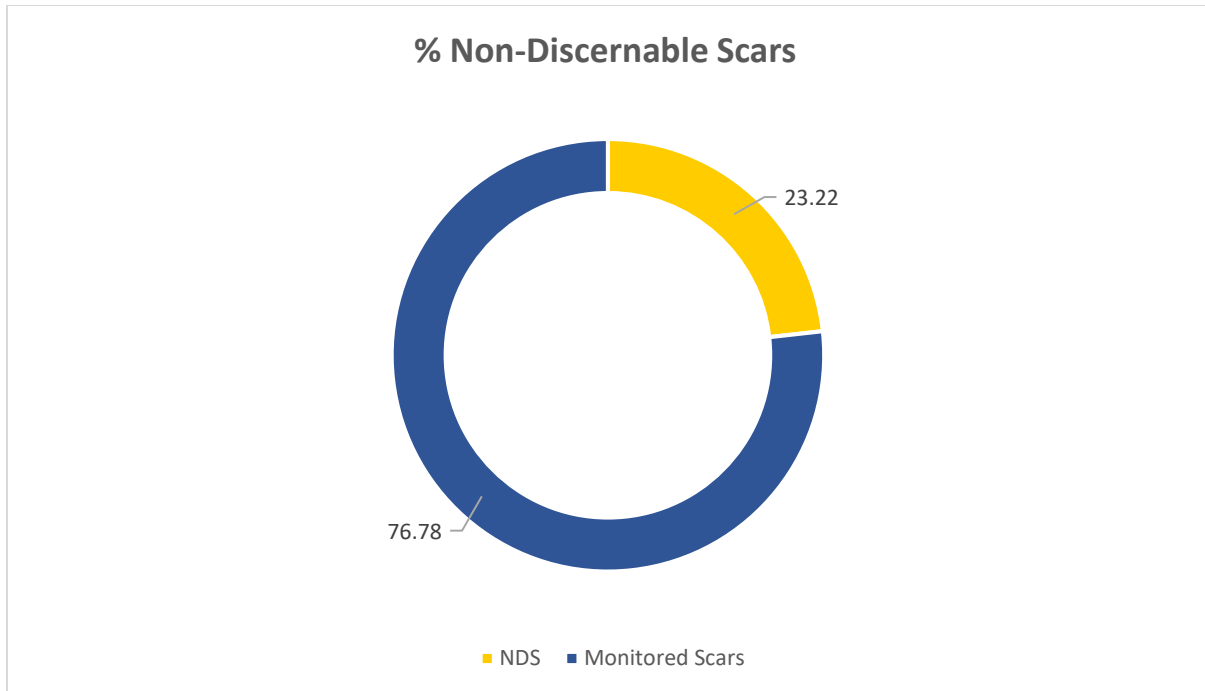
able to be located and were therefore labeled as “No Discernable Scar” (Figure 18). These scars were usually located in areas where seagrass beds had become denuded, leaving large expanses of sandy bottom where scars could no longer be seen. It is suspected that increased urchin grazing pressure contributed to the creation of these bare areas.

Figure 18: Percent of the 379 treated scars that were monitored vs. non-discernible.

Urchin grazing has been seen in several areas of restoration, including PSR 6, PSR 8, PSR 4, and PSR 11. PSR 6 was the most impacted by the urchin grazing, containing 63 of the 89 non-discernible scars documented. PSR 8 was the next most impacted area, with 21 of the non-discernible scars. In these areas, what once were extensive seagrass beds are now large expanses of mostly bare sand, likely due to urchin grazing. Large numbers of urchins are present in these areas, and the only seagrass that typically remains has been cut down to the sediment. Other factors that could contribute to this loss include water quality, sea turtle grazing, and human disturbance. If non-discernible scars are not included in the analysis, 12.41% of all scars monitored to date have been restored to an average B&B score of at least 3, which is 87.59% off of the goal to have 100% of restored scars at a B&B score of at least 3 by Year 2.

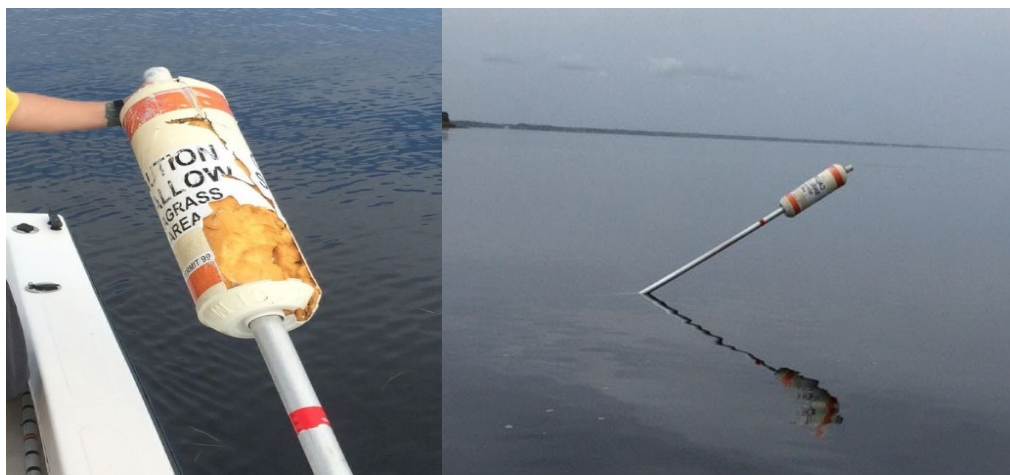
The Shallow Seagrass Buoy System, comprised of 49 buoys marking shallow seagrass areas in the southern end of St. Joseph Bay (Figure 22), was completed in May 2016. In 2017, nine of the buoys installed were leaning and/or had been damaged and were replaced. Over the next few years, more damage occurred to the buoy system, and most of the buoys were either missing or damaged (Figure 23). Much of this damage was caused by boaters and Hurricane Michael in October 2018. Due to the extent of the damage, the system became a hazard to boaters and was removed in June 2020. As an alternative to the buoy system, efforts are now focused on increasing boater awareness of seagrasses through outreach, education, and signage. Some of these efforts include updates to existing signage where applicable, installation of educational signage, and provision of brochures about best practices for protecting seagrass habitats at popular boat ramps in St. Joseph Bay, Alligator Harbor, and St. Andrews Bay (Figure 24).

Figure 23. Examples of damaged and fallen seagrass buoys.
