**Natural Resource Damage Assessment
Florida Seagrass Recovery Project
Monitoring Report 2022
Last Updated 7/18/2022**

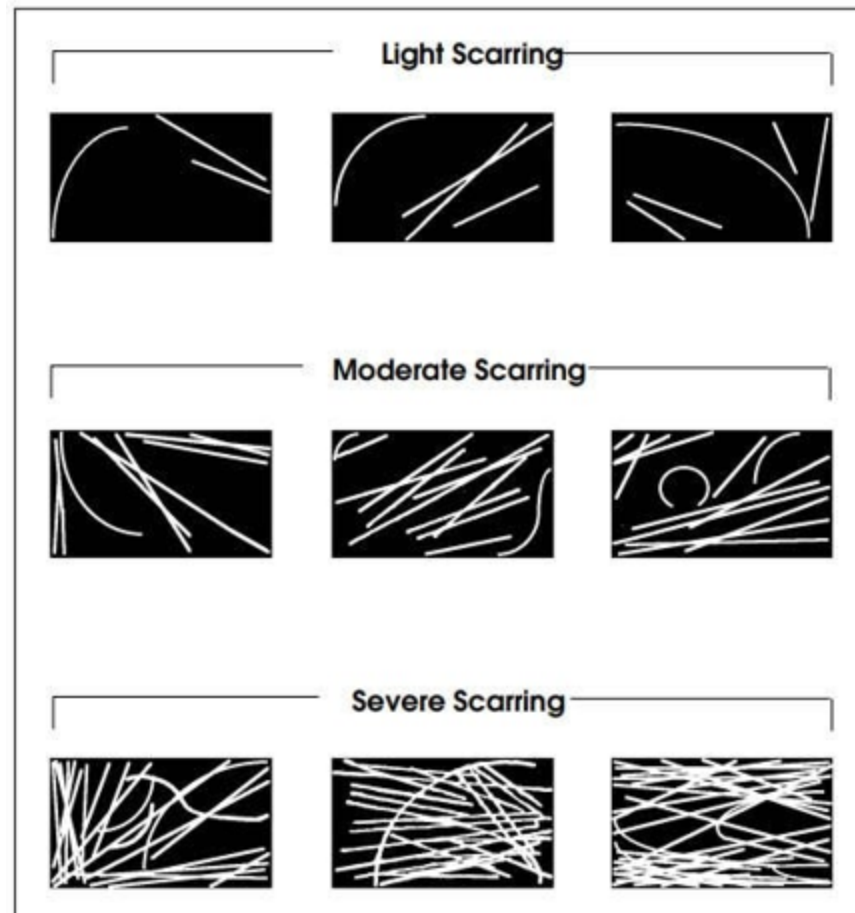
Once the PSR polygons were established, the intensity of scarring for each polygon was categorized based on the Comparison Chart for Visual Estimation of Percent Composition (Sargent et al. 1995). Polygons were designated as light (less than 5% scarring) intensity, moderate (5-20% scarring) intensity, and severe (more than 20% scarring) intensity (Figure 5). Moderate and severe intensity areas were the focus for restoration efforts.

Figure 5. Examples of light, moderate, and severe scarring, as explained by Sargent et al. 1995.

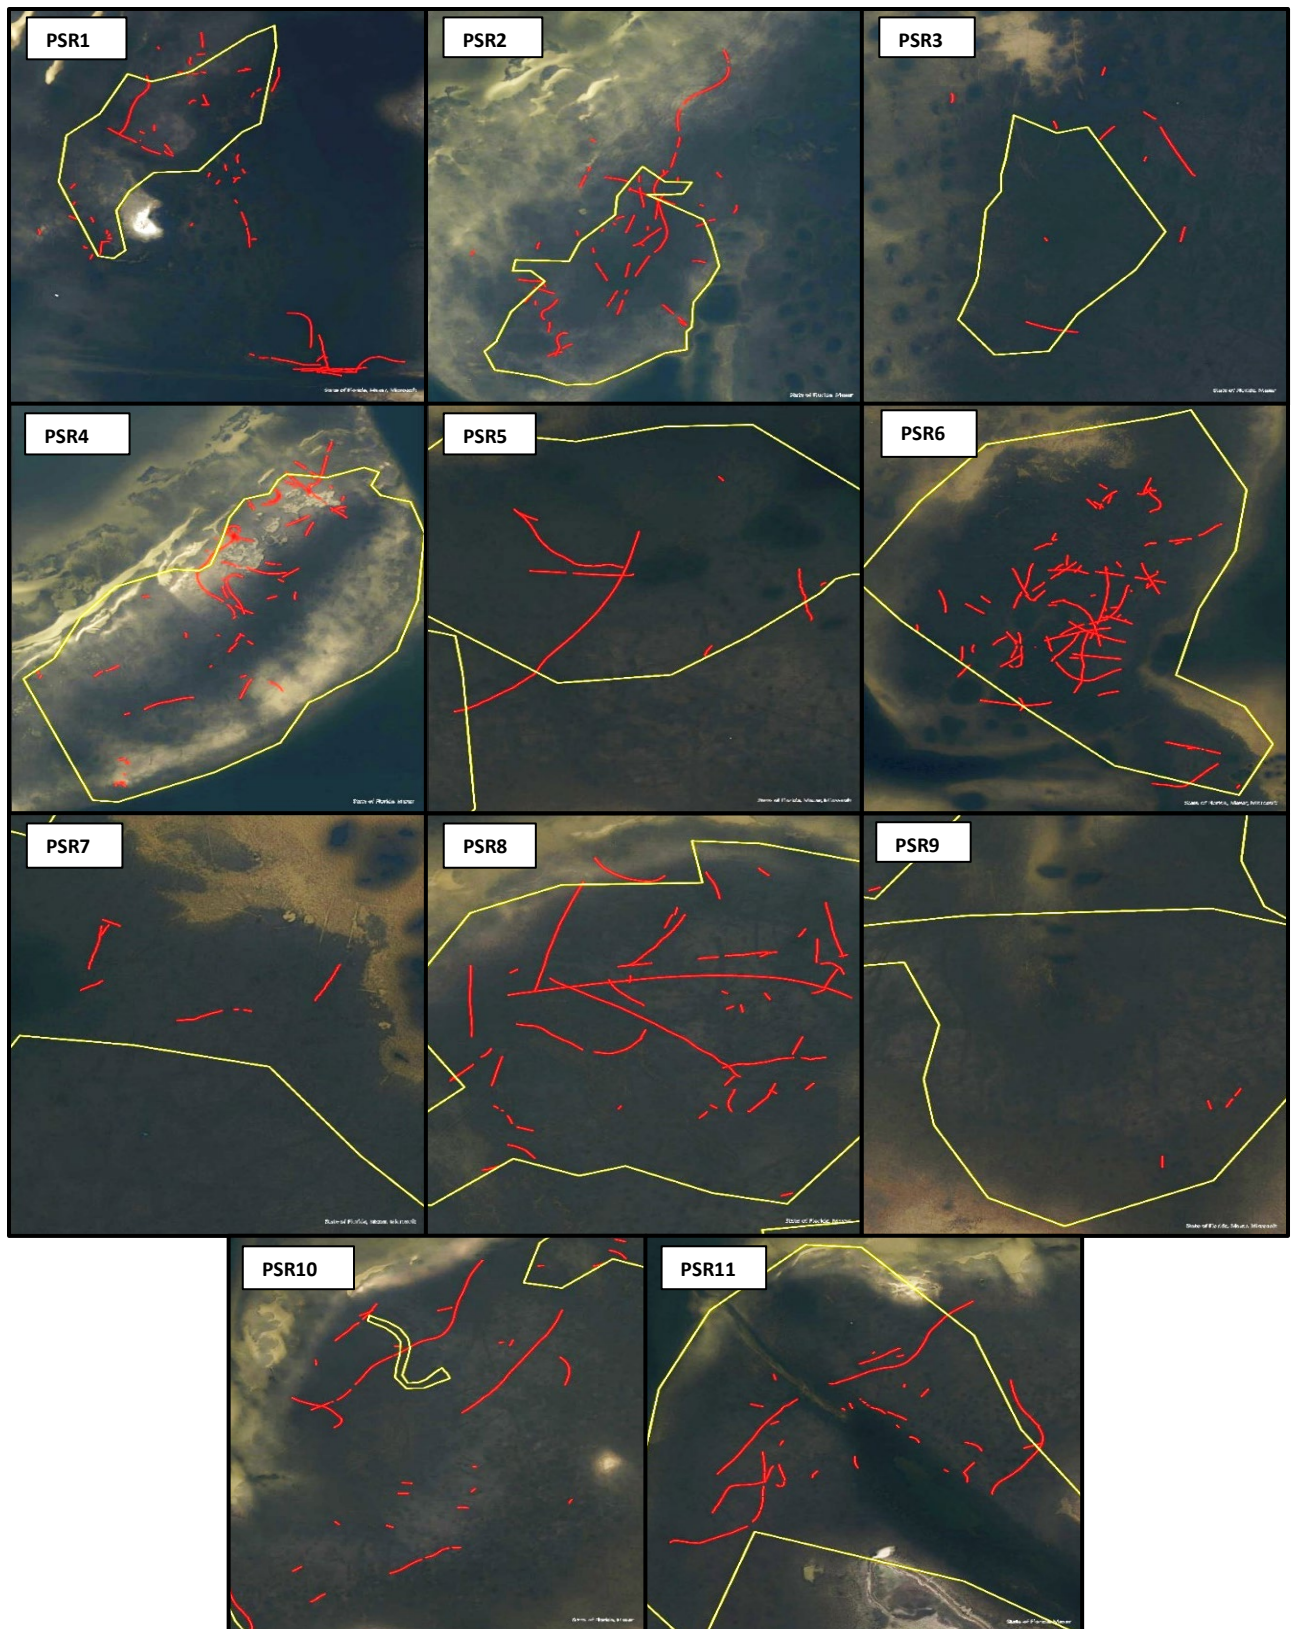
Figure 6. All propeller scars to be monitored during this project, sorted by PSR.

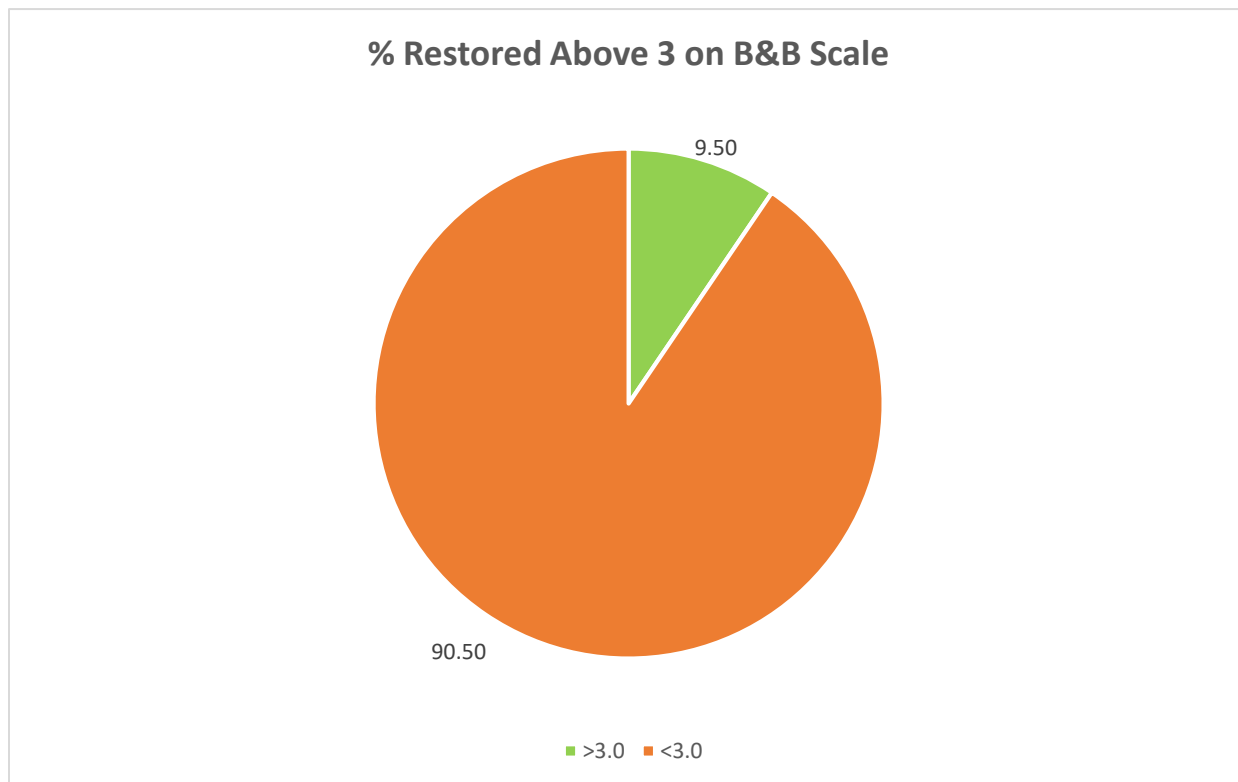
At Year One monitoring, 9.50% of treated propeller scars had been restored to a B&B score of at least 3 (Figure 15), while 51.19% had been restored to a B&B score of at least 1 (Figure 16). Of the 379 scars that were treated with sediment tubes, 32 (8.44% of total scars restored) scars had an average B&B score less than 0.5, 62 (16.36%) had an average B&B score between 0.5 and 0.9, 104 (27.44%) had an average B&B score between 1.0 and 1.9, 56 (14.78%) had an average B&B score between 2.0 and 2.9, 25 (6.60%) had an average B&B score between 3.0 and 3.9, and 11 scars (2.90%) had an average B&B score between 4.0 and 5.0 (Figure 17). Of the 379 scars monitored, 88 (23.22% of all restored scars) were not

Figure 15: Percent of treated scars (out of 379) restored to an average B&B score of at least 3 at Year 1.

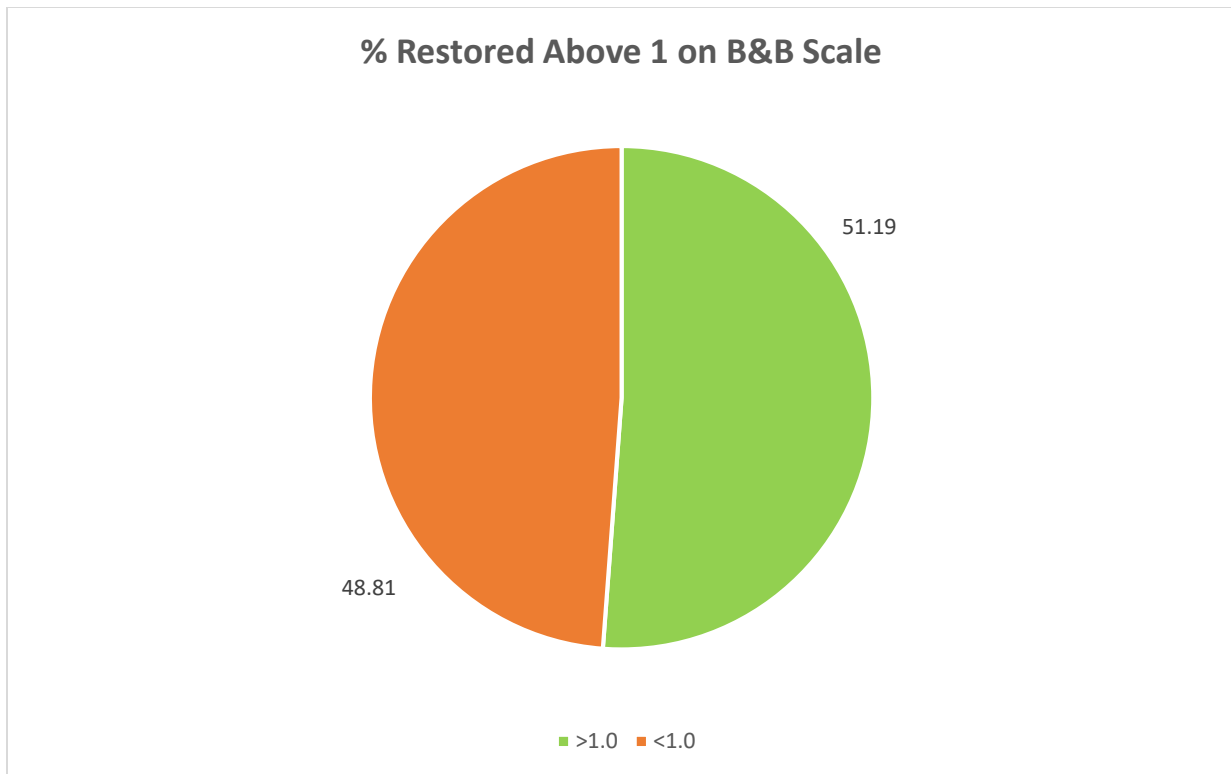
Figure 16: Percent of treated scars (out of 379) restored to an average B&B score of at least 1 at Year 1

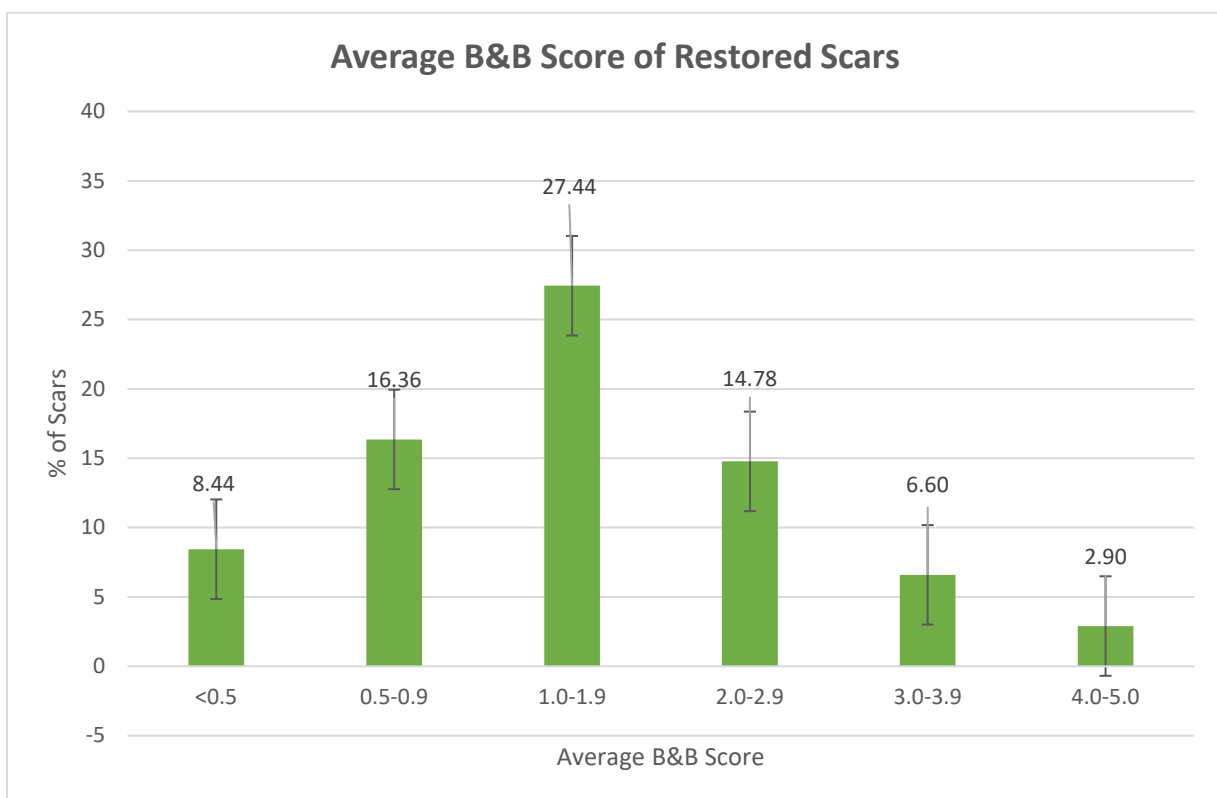
Figure 17: Distribution of the Average B&B Score of Restored Scars after one year, out of all 379 scars originally restored. Error bars represent the standard error.

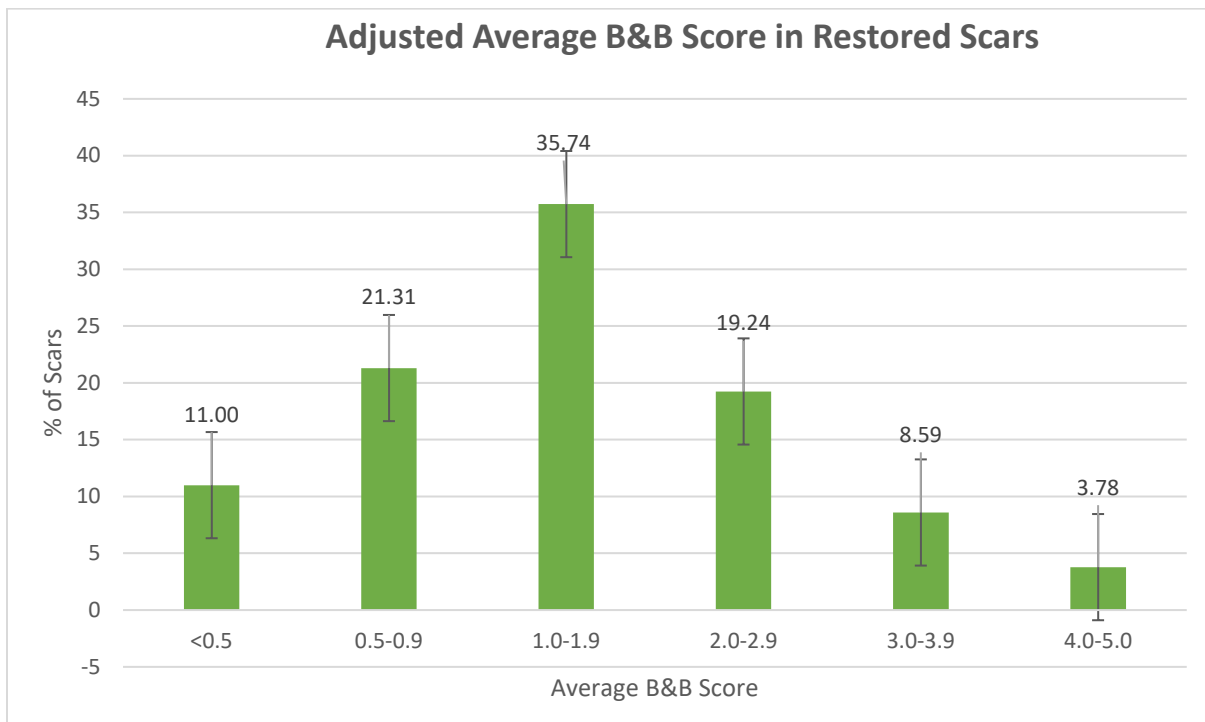
Since unexpected urchin grazing has impacted healthy seagrass and restored scars in some PSRs, adjusted percentages were also calculated to account for the non-discernible scars located in these areas. With these adjusted numbers, 3% have been restored to an average B&B score of 0.49 or less, 21.38% have been restored to an average B&B score of 0.5-0.9, 35.86% have been restored to an average B&B score of 1.0-1.9, 19.31% have been restored to an average B&B score of 2.0-2.9, 8.62% have been restored to an average B&B score of 3.0-3.9, and 3.79% have been restored to an average B&B score of 4.0-5.0 (Figure 19). Of the monitored scars (adjusted to account for non-discernible scars), 66.90% have been restored to an average B&B score of at least 1.0 (Figure 20), and 12.41% have been restored to an average B&B score of at least 3 (Figure 21). So far, the total average B&B score of all monitored scars is 1.50.

Figure 19: Distribution of the Adjusted Average B&B Score of Restored Scars after one year, of 291 monitored scars. Error bars represent the standard error.

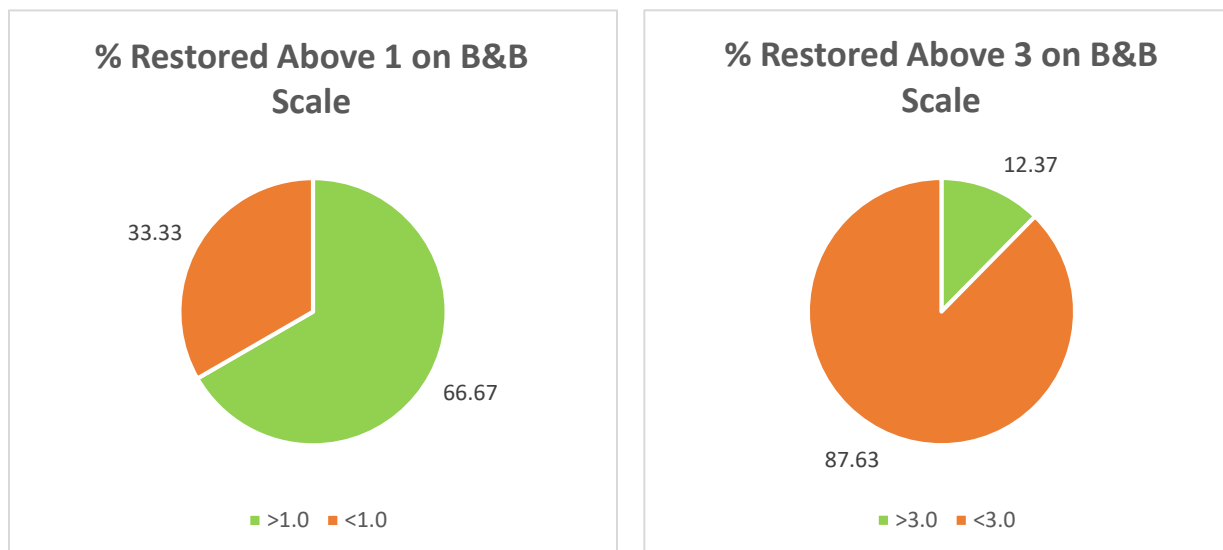
Figure 20 and Figure 21: Adjusted percent of monitored scars (291) restored to an average B&B score of at least 1 and 3, respectively, at Year 1

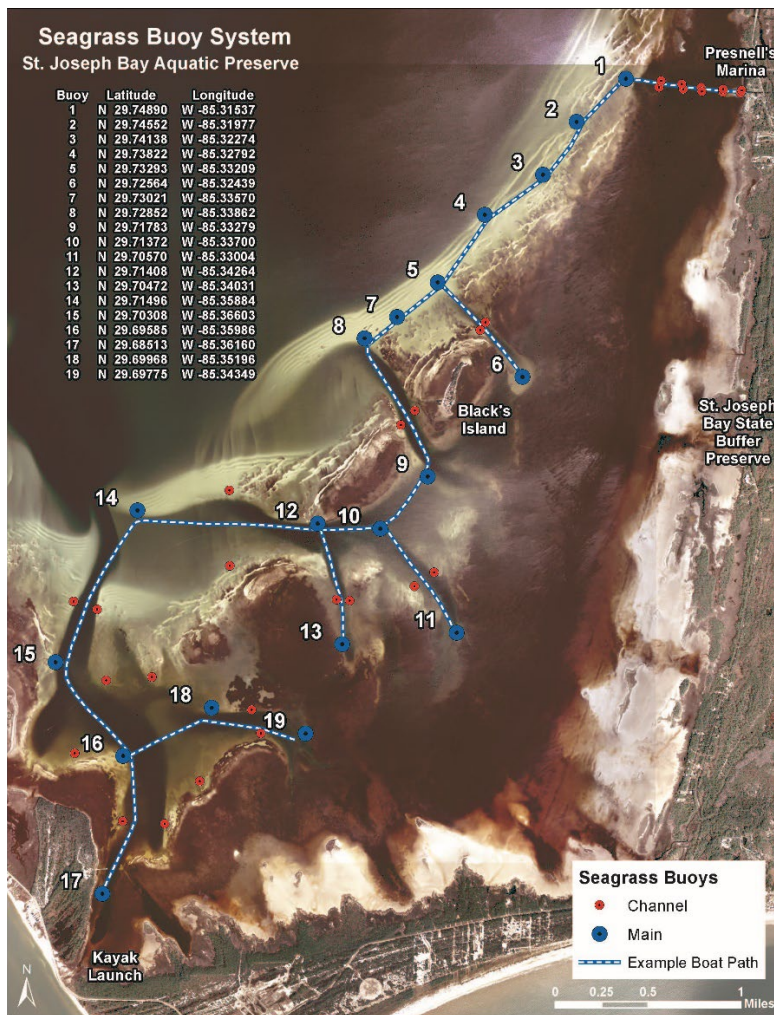
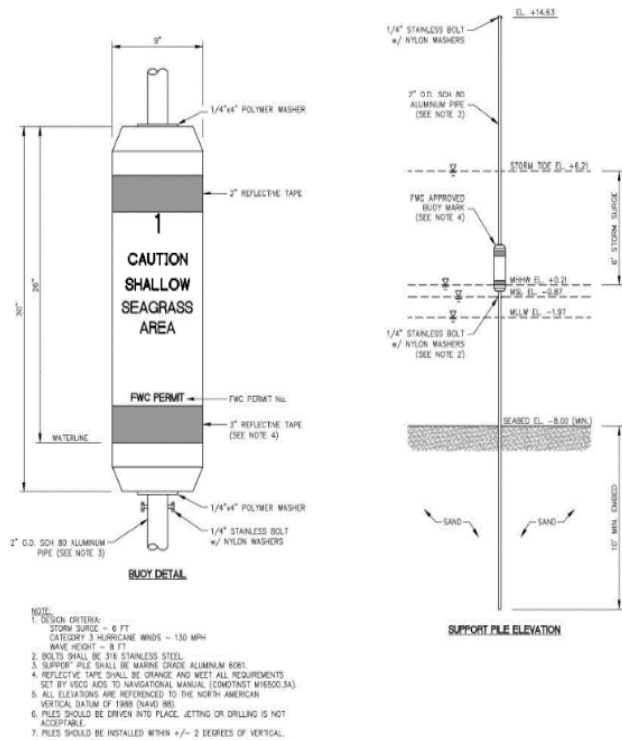
The Shallow Seagrass Buoy System, comprised of 49 buoys marking shallow seagrass areas in the southern end of St. Joseph Bay (Figure 22), was completed in May 2016. In 2017, nine of the buoys installed were leaning and/or had been damaged and were replaced. Over the next few years, more damage occurred to the buoy system, and most of the buoys were either missing or damaged (Figure 23). Much of this damage was caused by boaters and Hurricane Michael in October 2018. Due to the extent of the damage, the system became a hazard to boaters and was removed in June 2020. As an alternative to the buoy system, efforts are now focused on increasing boater awareness of seagrasses through outreach, education, and signage. Some of these efforts include updates to existing signage where applicable, installation of educational signage, and provision of brochures about best practices for protecting seagrass habitats at popular boat ramps in St. Joseph Bay, Alligator Harbor, and St. Andrews Bay (Figure 24).

Figure 22. Schematic of buoys (Right) and map for the Shallow Seagrass Buoy system completed in 2016.
